Manhole Inspection Summary

Manhole # S21E__002MH

Location Address: **1820 SARATOGA ST**

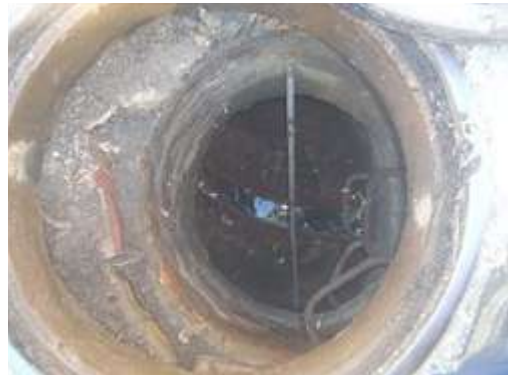
Defect 1

DEBRIS ON BENCH

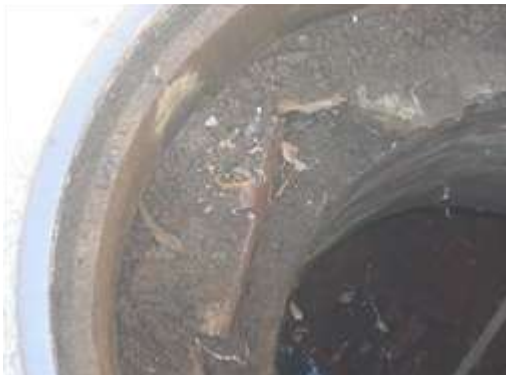
Defect 3

Frame Offset: **4** (in.) Condition: ☒ Sound ☐ Cracked ☐ Leaks

FRAME OFFSET

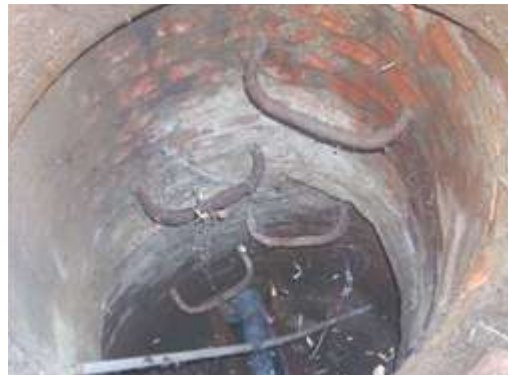
Defect 2

Steps Count: **4** Missing: **0** ☒ **Corroded**

CORRODED STEPS

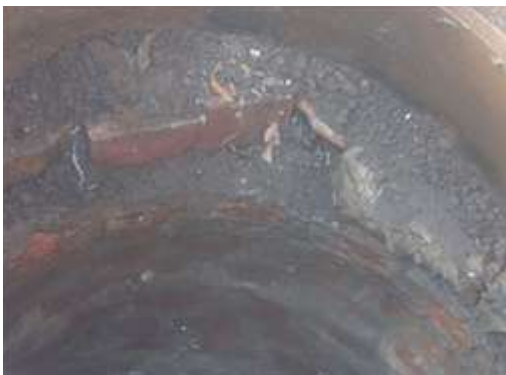
Condition: ☐ Sound ☐ Cracked ☐ Root Intrusion ☐ Loose Brick ☒ **Deteriorated**

CHIMNEY DETERIORATION

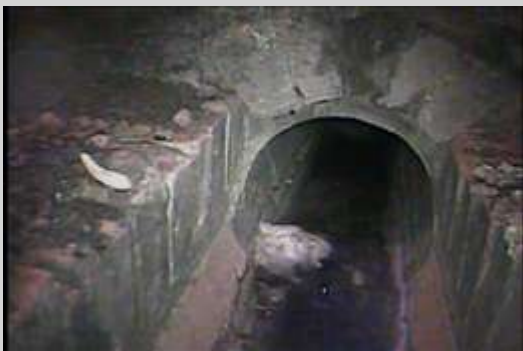
3 O'Clock Inflow

Pipe Height: **7.2** (in.) Rod and Bar (Angled)
Pipe Material: **Clay** ☐ Pipe Lined
Invert Depth: **7.89** (ft.) Flow Characteristics: **Slow**
Deposits: ☐ None ☐ Mud ☐ Sludge ☒ **Debris** ☐ Grease
Silt Depth: **1** (in.) Deposits Extent: **Light**
Infiltration: **None** Pipe Seal Cond: **Sound**
